ADVISORY CIRCULAR 43-16A

AVIATION MAINTENANCE ALERTS

ALERT
NUMBER
288

JULY
2002

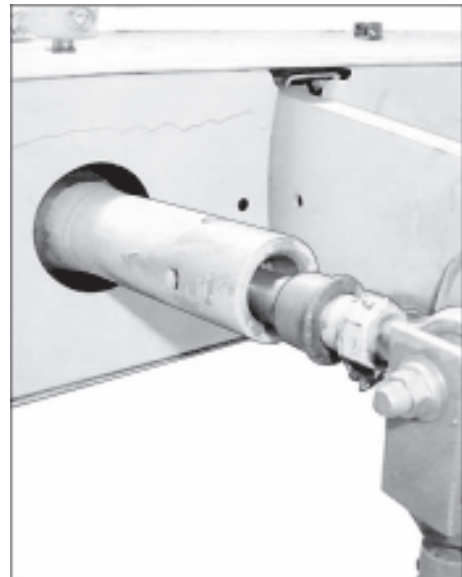
Beech; Model 200; King Air; Flight Control Defect; ATA 5513

After removing the elevator, the technician discovered the bushing, installed in the end of the tab actuator (P/N 101-524072-1), was very loose on the shaft. (Refer to the illustration.) Failure of this bushing presents the possibility of trim tab flutter and/or restriction of the tab travel.

The submitter recommended the manufacturer consider the implementation of a procedure to lock the bushing in place by using a roll pin or other suitable device to hold the bushing in place. He suggested that all operators of like aircraft conduct a one-time inspection of the bushing and elevator trim tab assembly for security and condition.

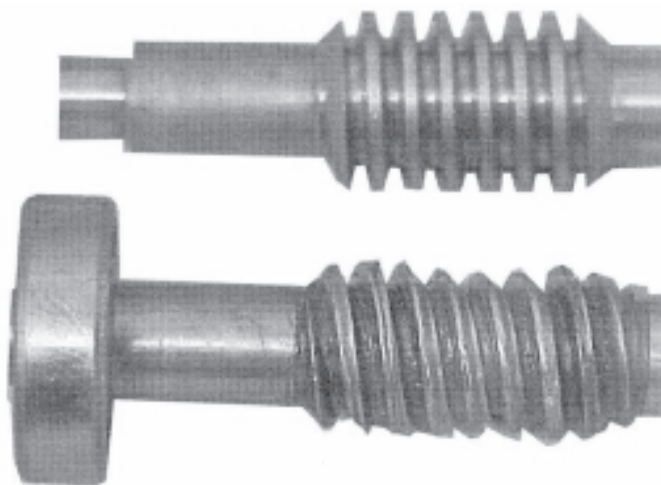
MOONEY**Mooney; Model M20J; Defective Landing Gear Component; ATA 3230**

The electric landing gear actuator (Dukes P/N 1057-00-05) was removed and sent to a certified repair station for evaluation. The disassembly and evaluation was done in the presence of an FAA Airworthiness Inspector and repair station personnel. This resulted in finding that the actuator worm shaft

gear teeth (or threads) were worn far beyond acceptable limits. The worm shaft was subjected to a Rockwell hardness test that revealed the shaft material was not hardened (too soft) to the proper specifications. (Refer to the illustration, which compares the worm shaft to a new part.)

This landing gear collapse incident occurred a short time after the worm gear assembly was replaced in accordance with Airworthiness Directive (AD) 75-23-04. The AD references Mooney Service Bulletin (SB) M20-190. Also, Mooney SB M20-189 contains additional information on this subject.

The submitter recommended revising the AD to include removing the actuator gears to allow a visual inspection of the parts for excessive wear that may not be apparent from a “gear backlash” test.

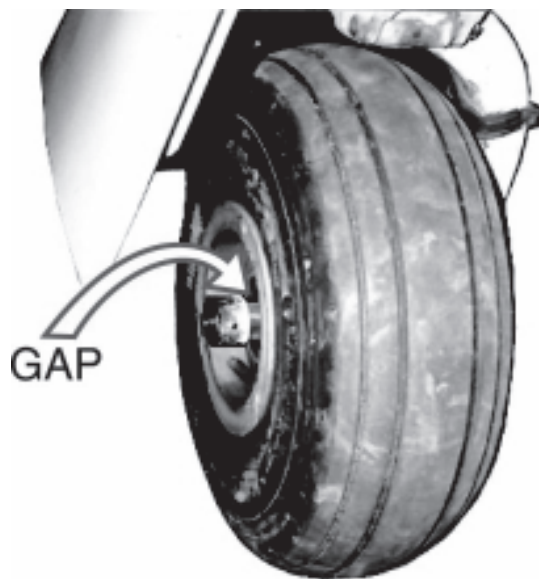
Piper; Model PA 28RT-201; Arrow; Improper Main Landing Gear Wheel Installation; ATA 3246

The wheel assembly axle nut (P/N 66820-00) was installed backward. In this configuration, it was necessary to back the nut off far enough to align the cotter pin hole, which left a large gap between the nut and the wheel assembly. (Refer to the illustration.) The axle was severely grooved by contact with the wheel and the bearings. The wheel brake assembly was given credit for at least limiting wheel assembly movement.

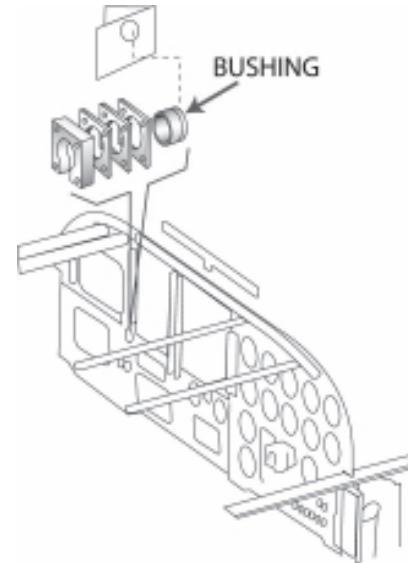
When the flight controls were freed, the pilot noticed the control column bushing (P/N 68273-02) was “frozen” to the shaft of the control yoke. (Refer to the illustration.) The “jerking” motion dislodged the bushing from the instrument panel attachment plate (P/N 68272-03).

The submitter speculated a lack of lubrication and the presence of corrosion between the inside diameter of the bushing and the control column shaft caused this problem.

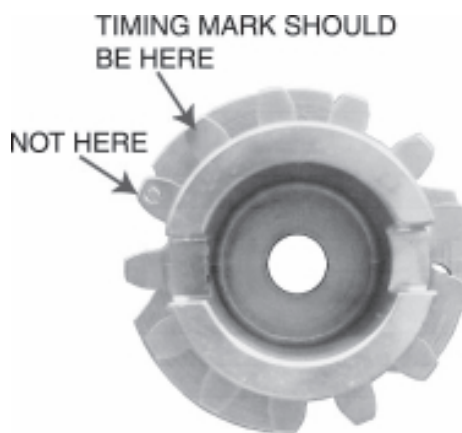
The submitter did not give the origin or disposition of the defective part.

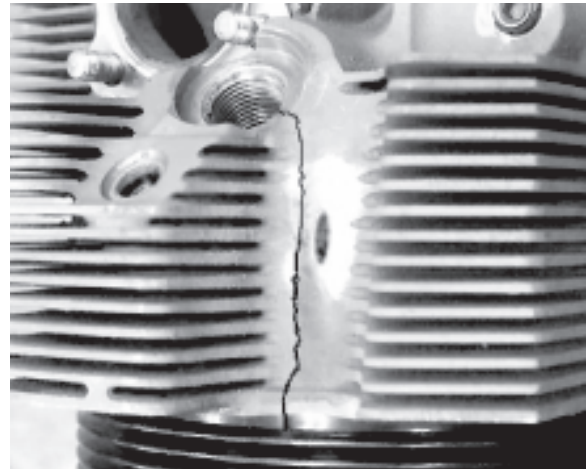
This cylinder was in service only a short time. The submitter urged technicians to conduct a thorough and searching receiving inspection prior to installing new cylinders.
